**Figure A-23**  
**Water-Level Elevations in USGS Meadowbrook Park Wells**

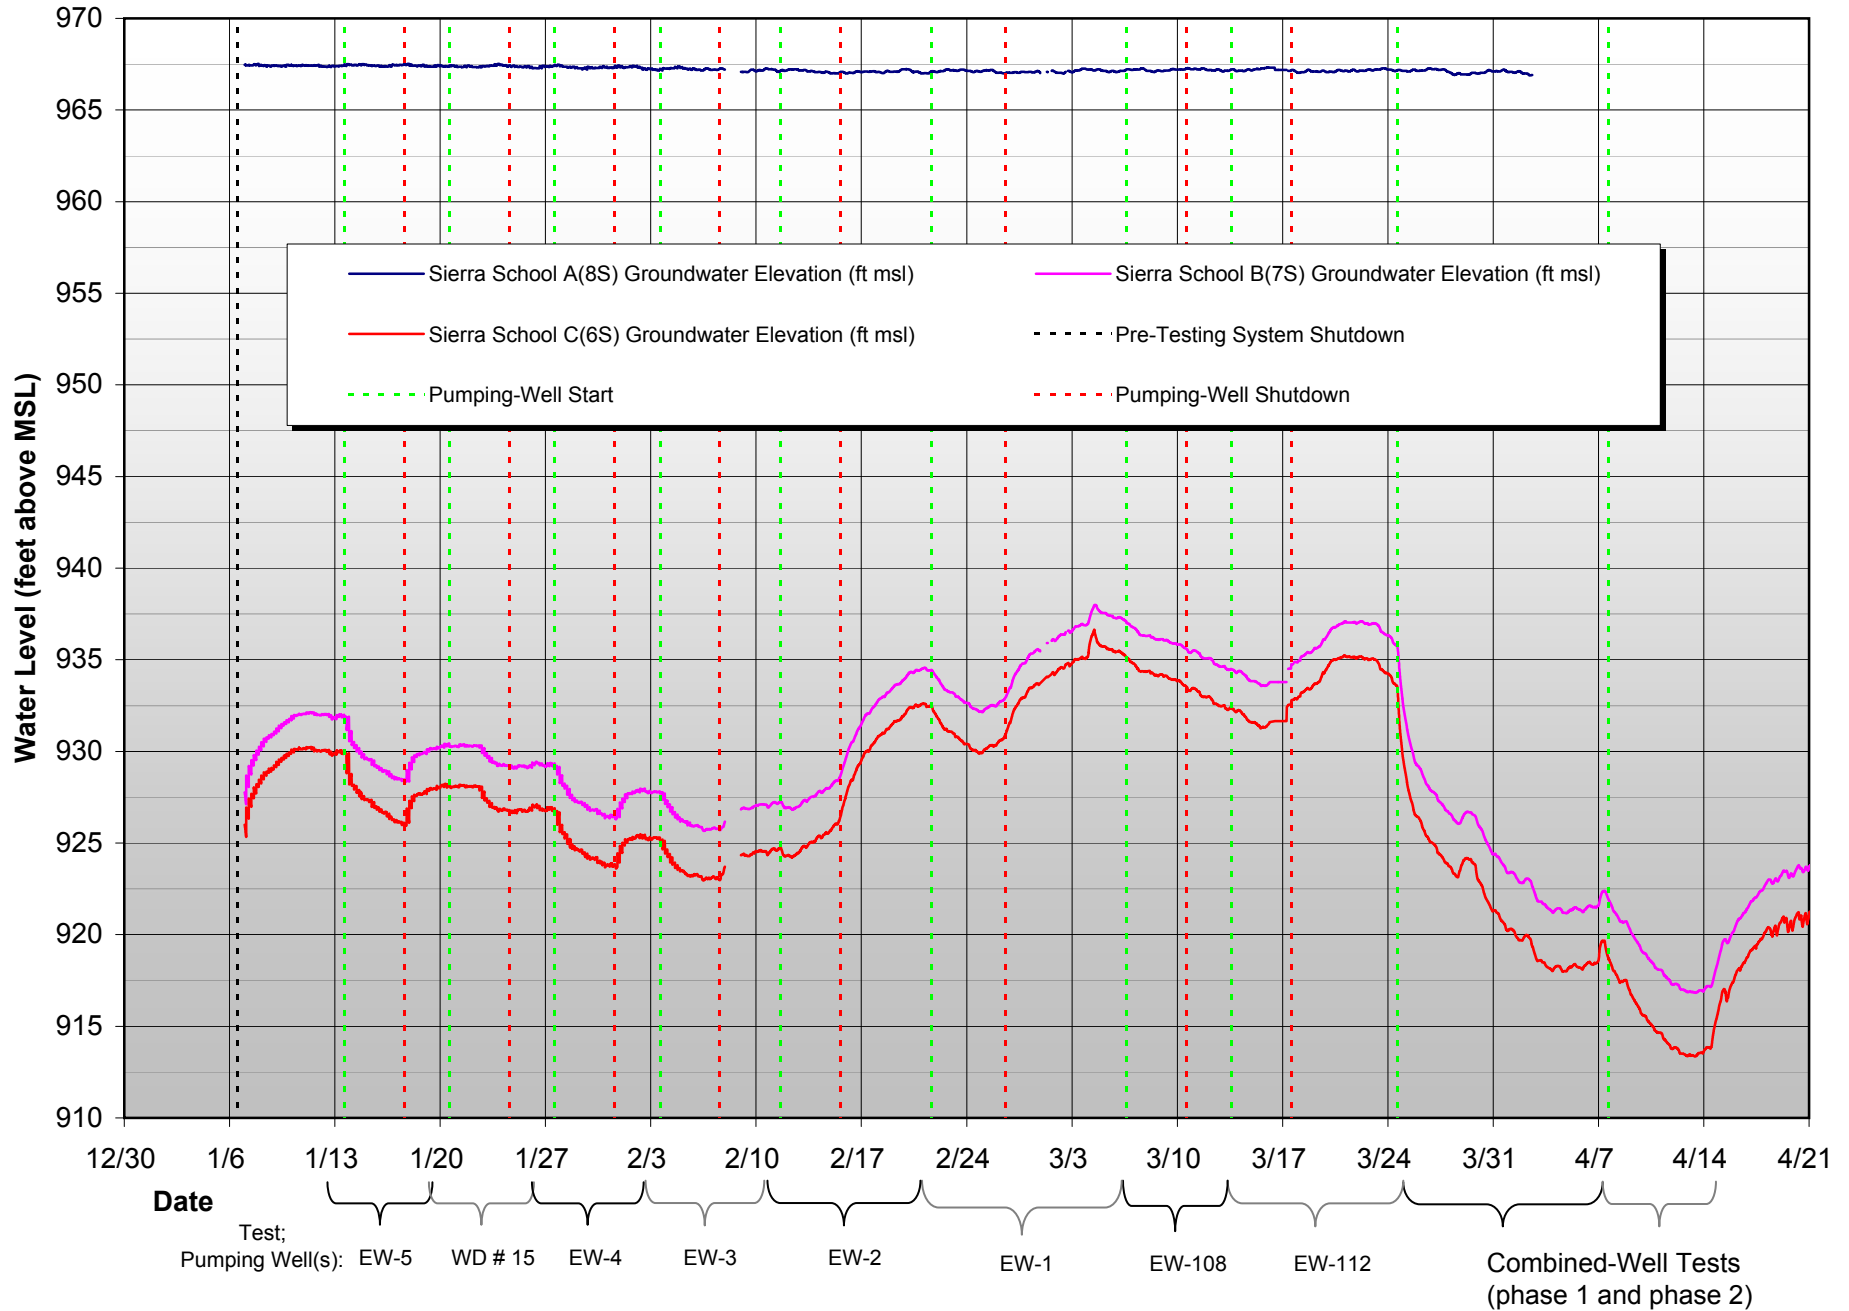
**Figure A-24**  
**Water-Level Elevations in USGS Sierra School Wells**

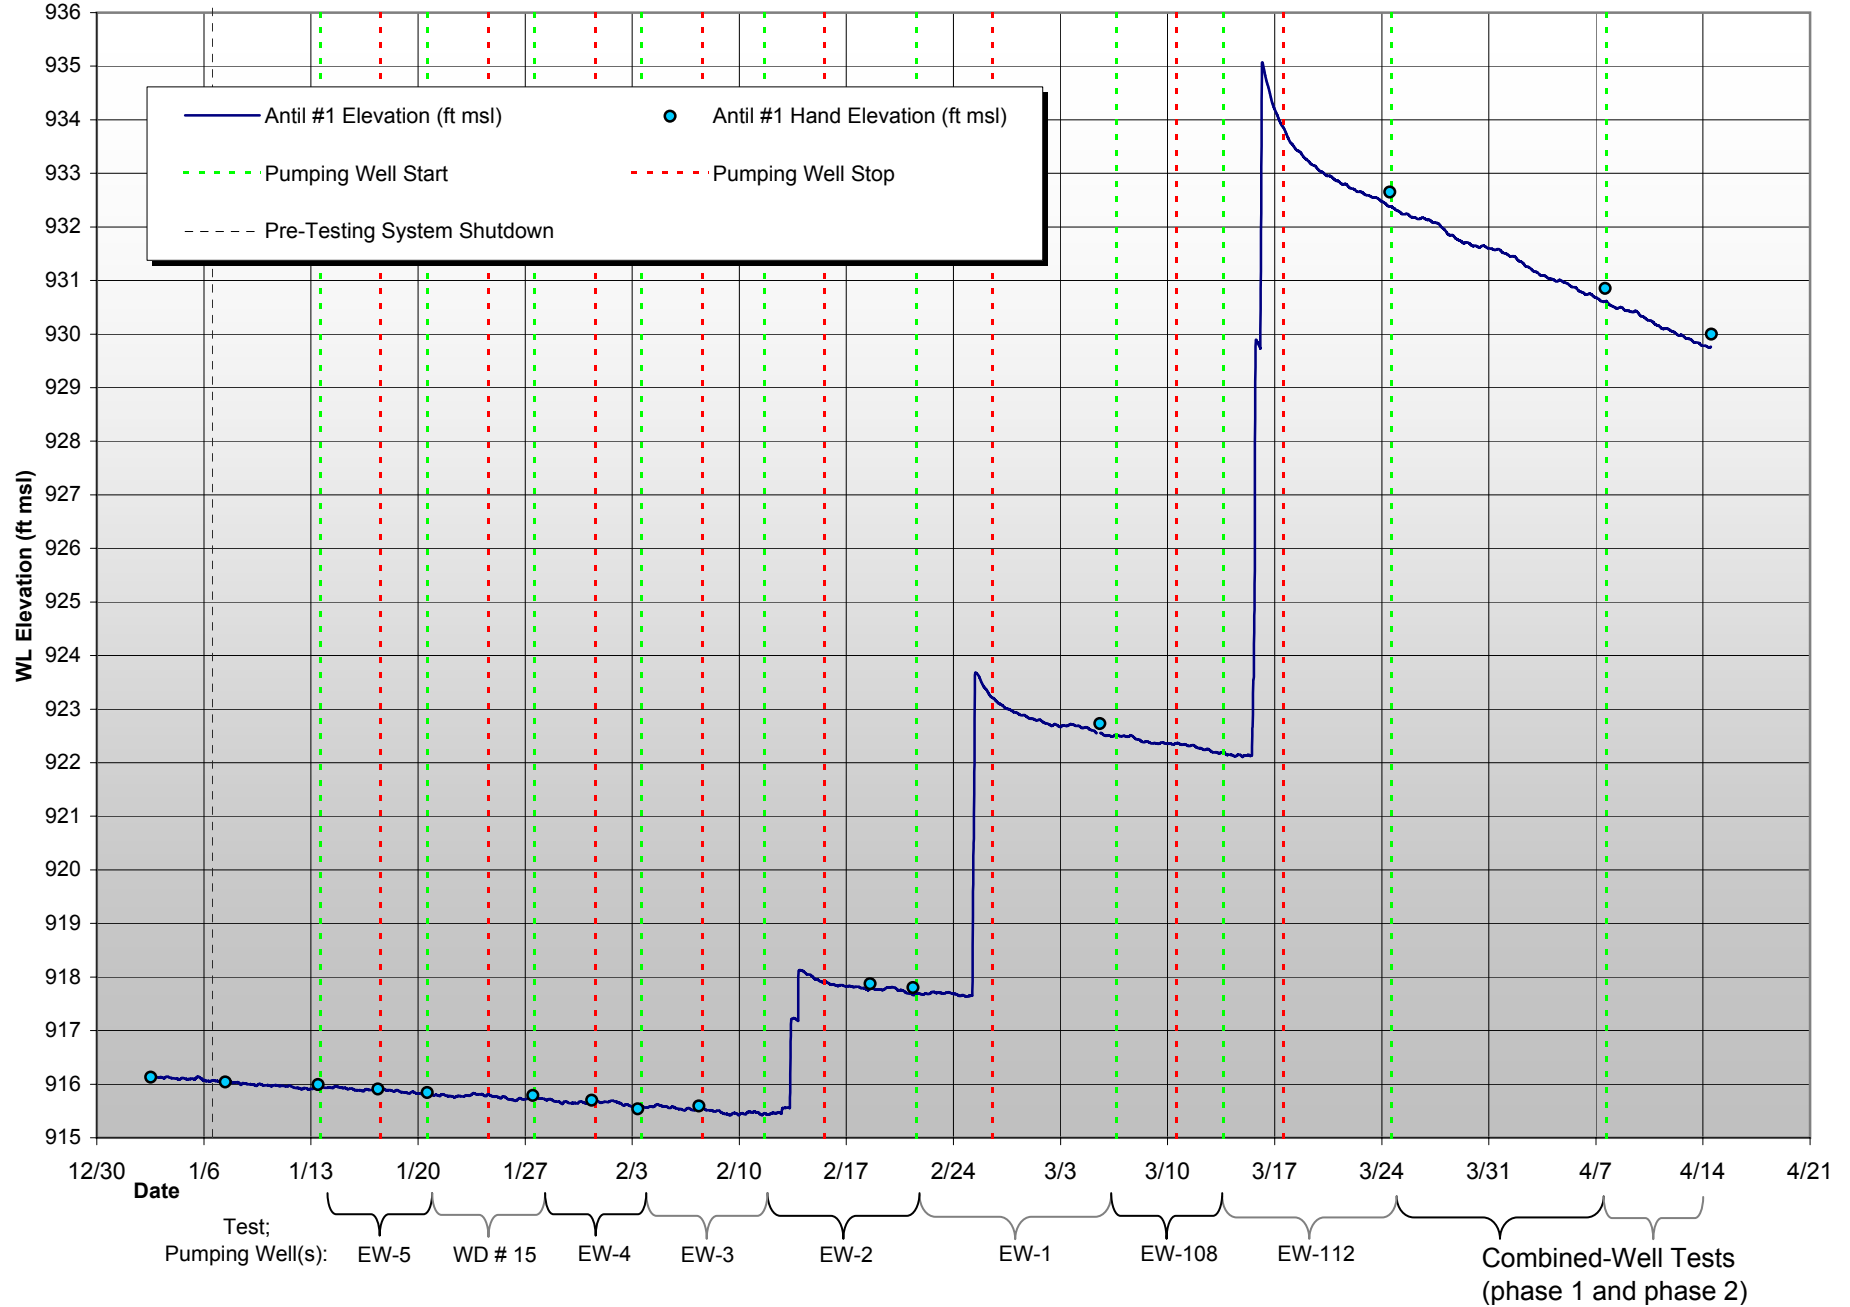
**Figure A-25**  
**Water-Level Elevations in Antil #1 Well**

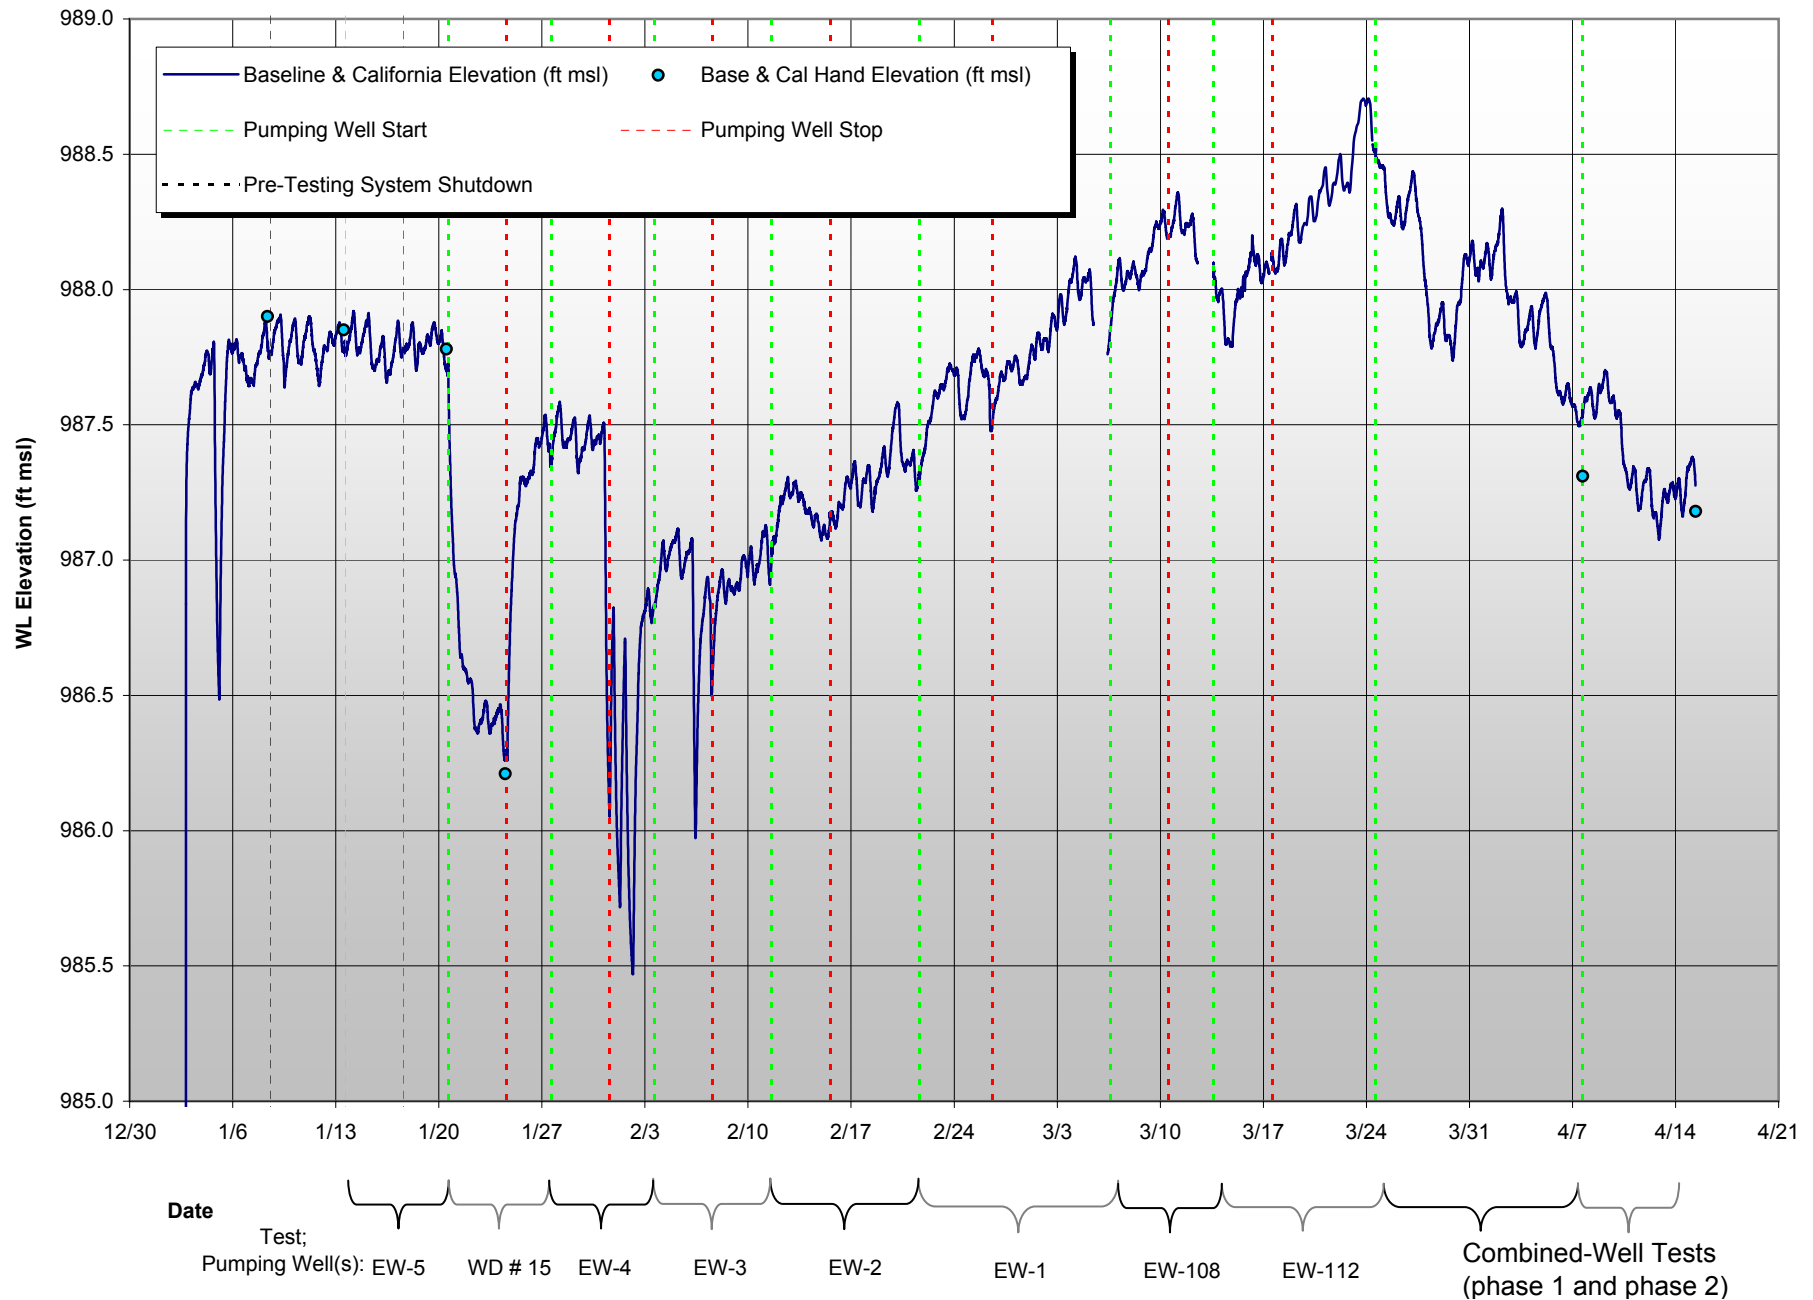
**Figure A-26**  
**Water-Level Elevations in Baseline & California Well**

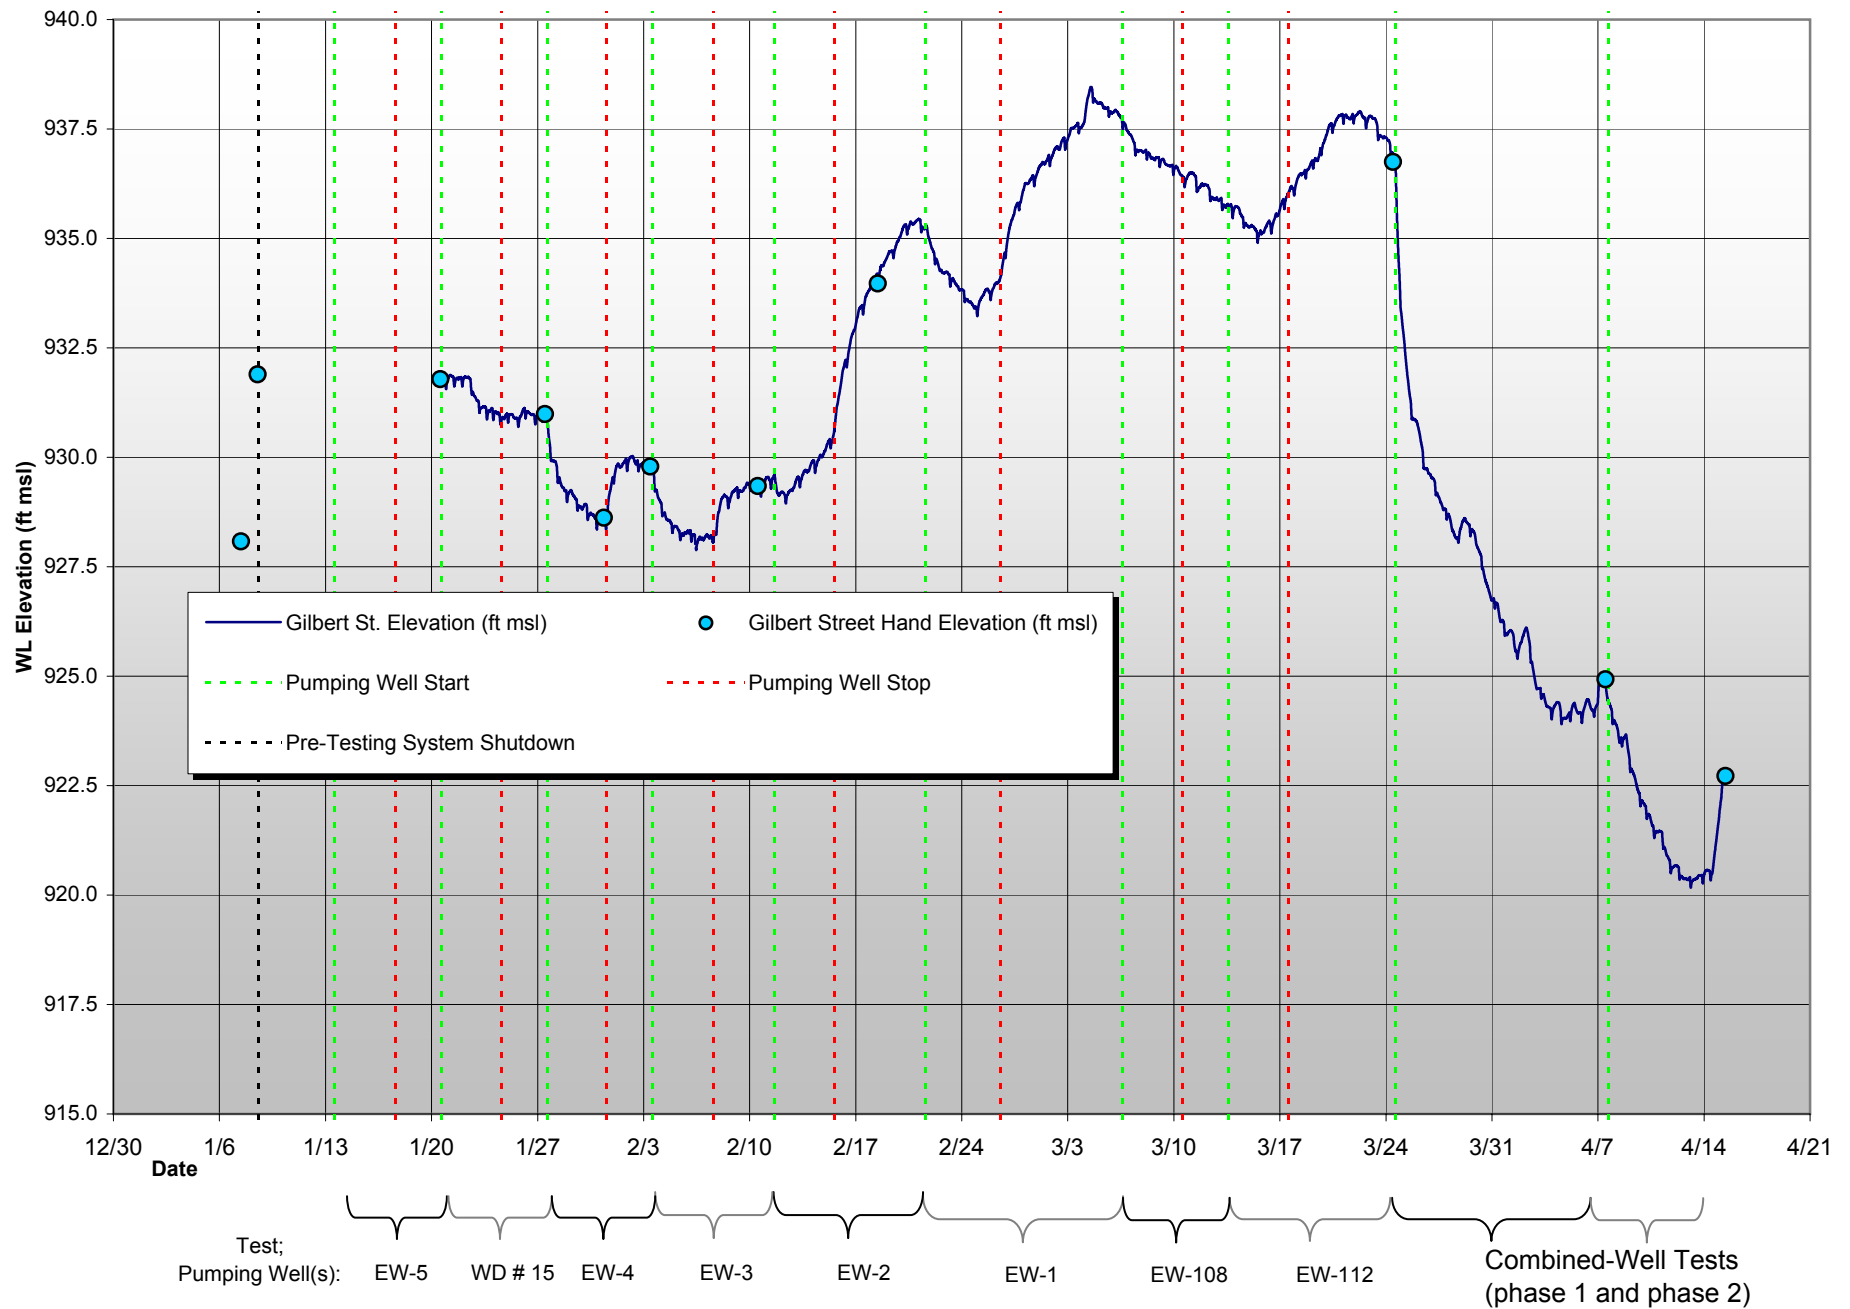
**Figure A-27**  
**Water-Level Elevations in Gilbert Street Well**

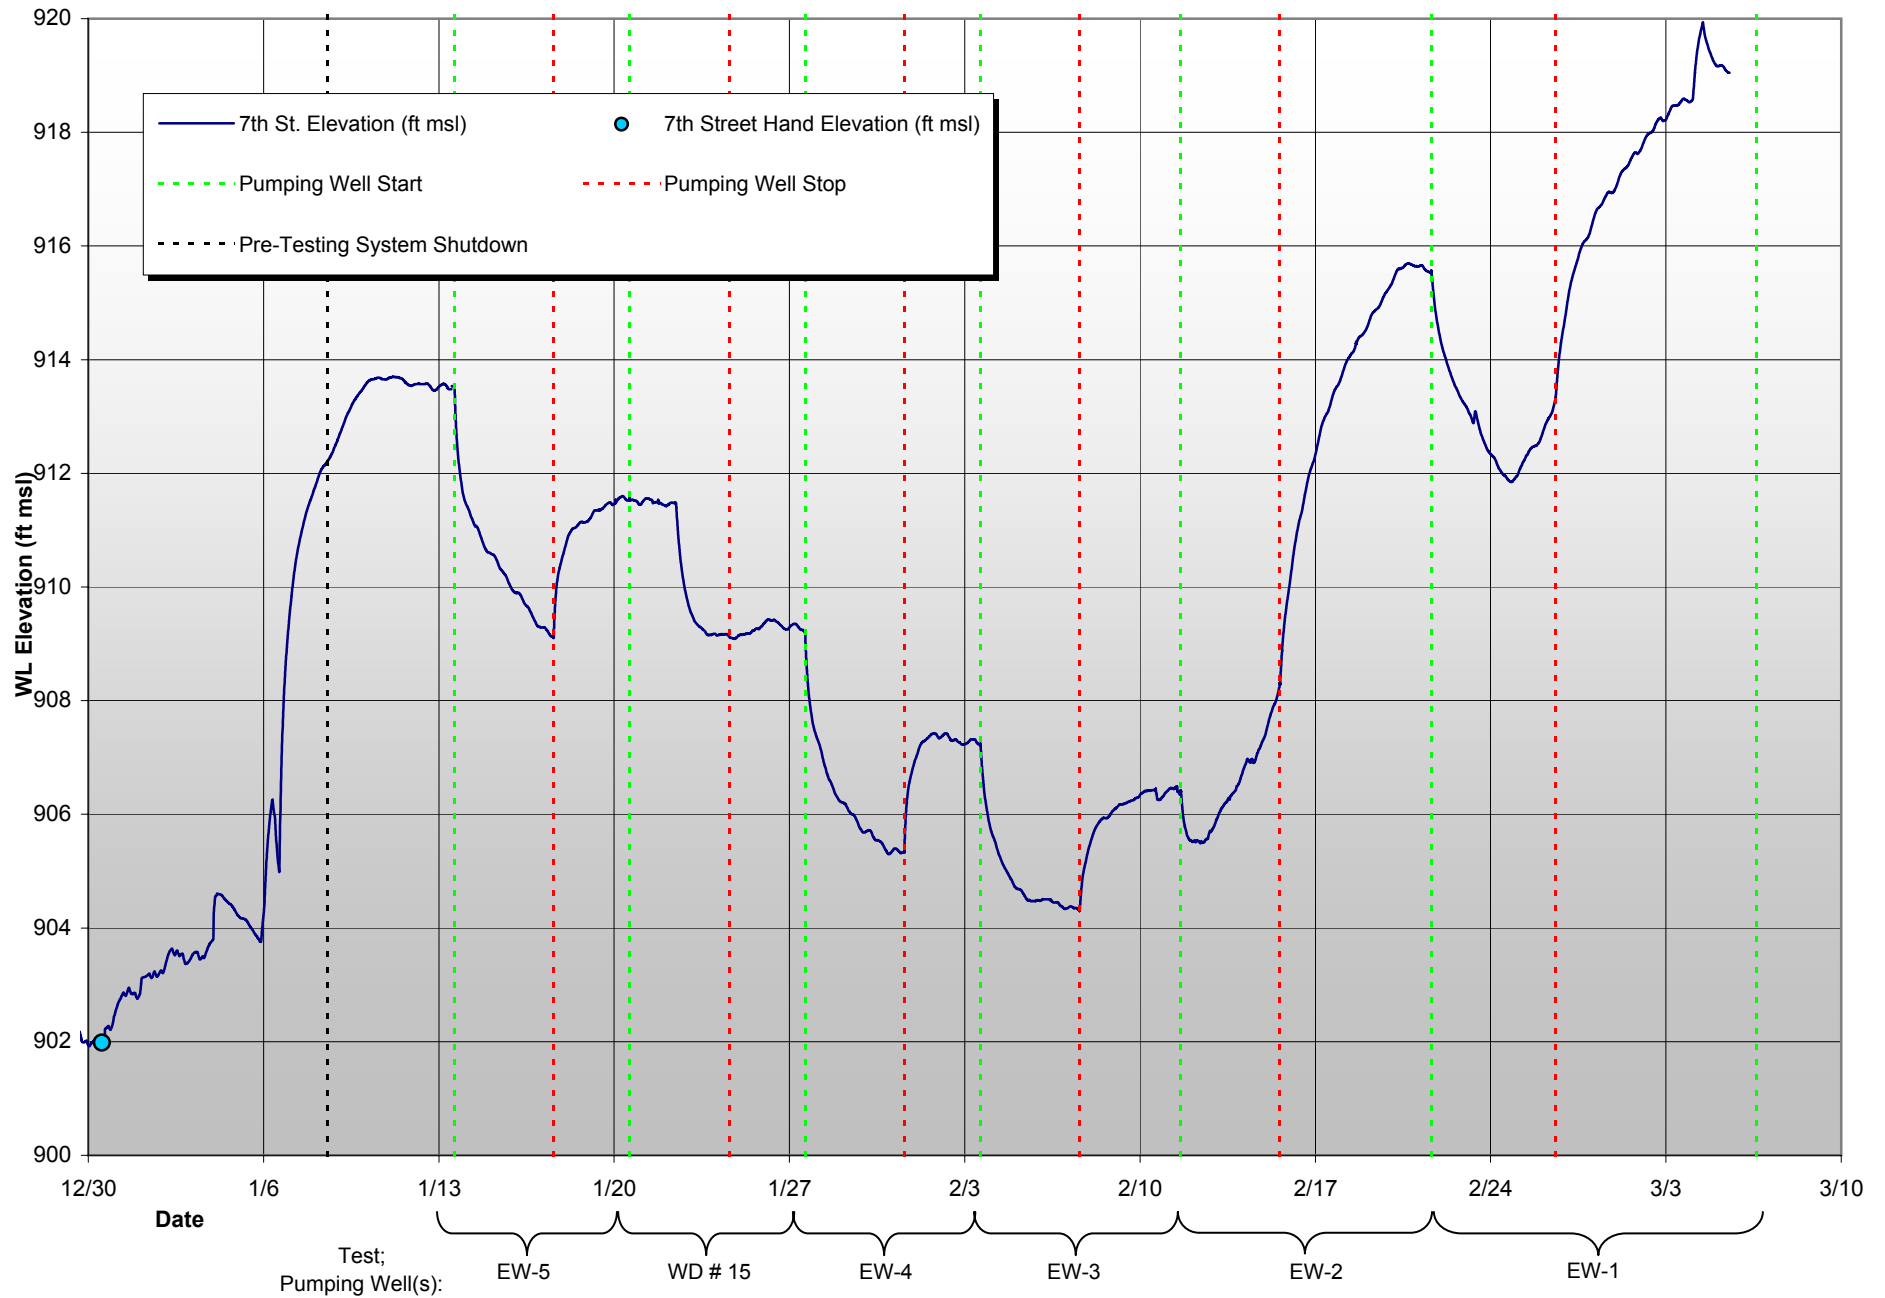
**Figure A-28**  
**Water-Level Elevations in 7th Street Well**

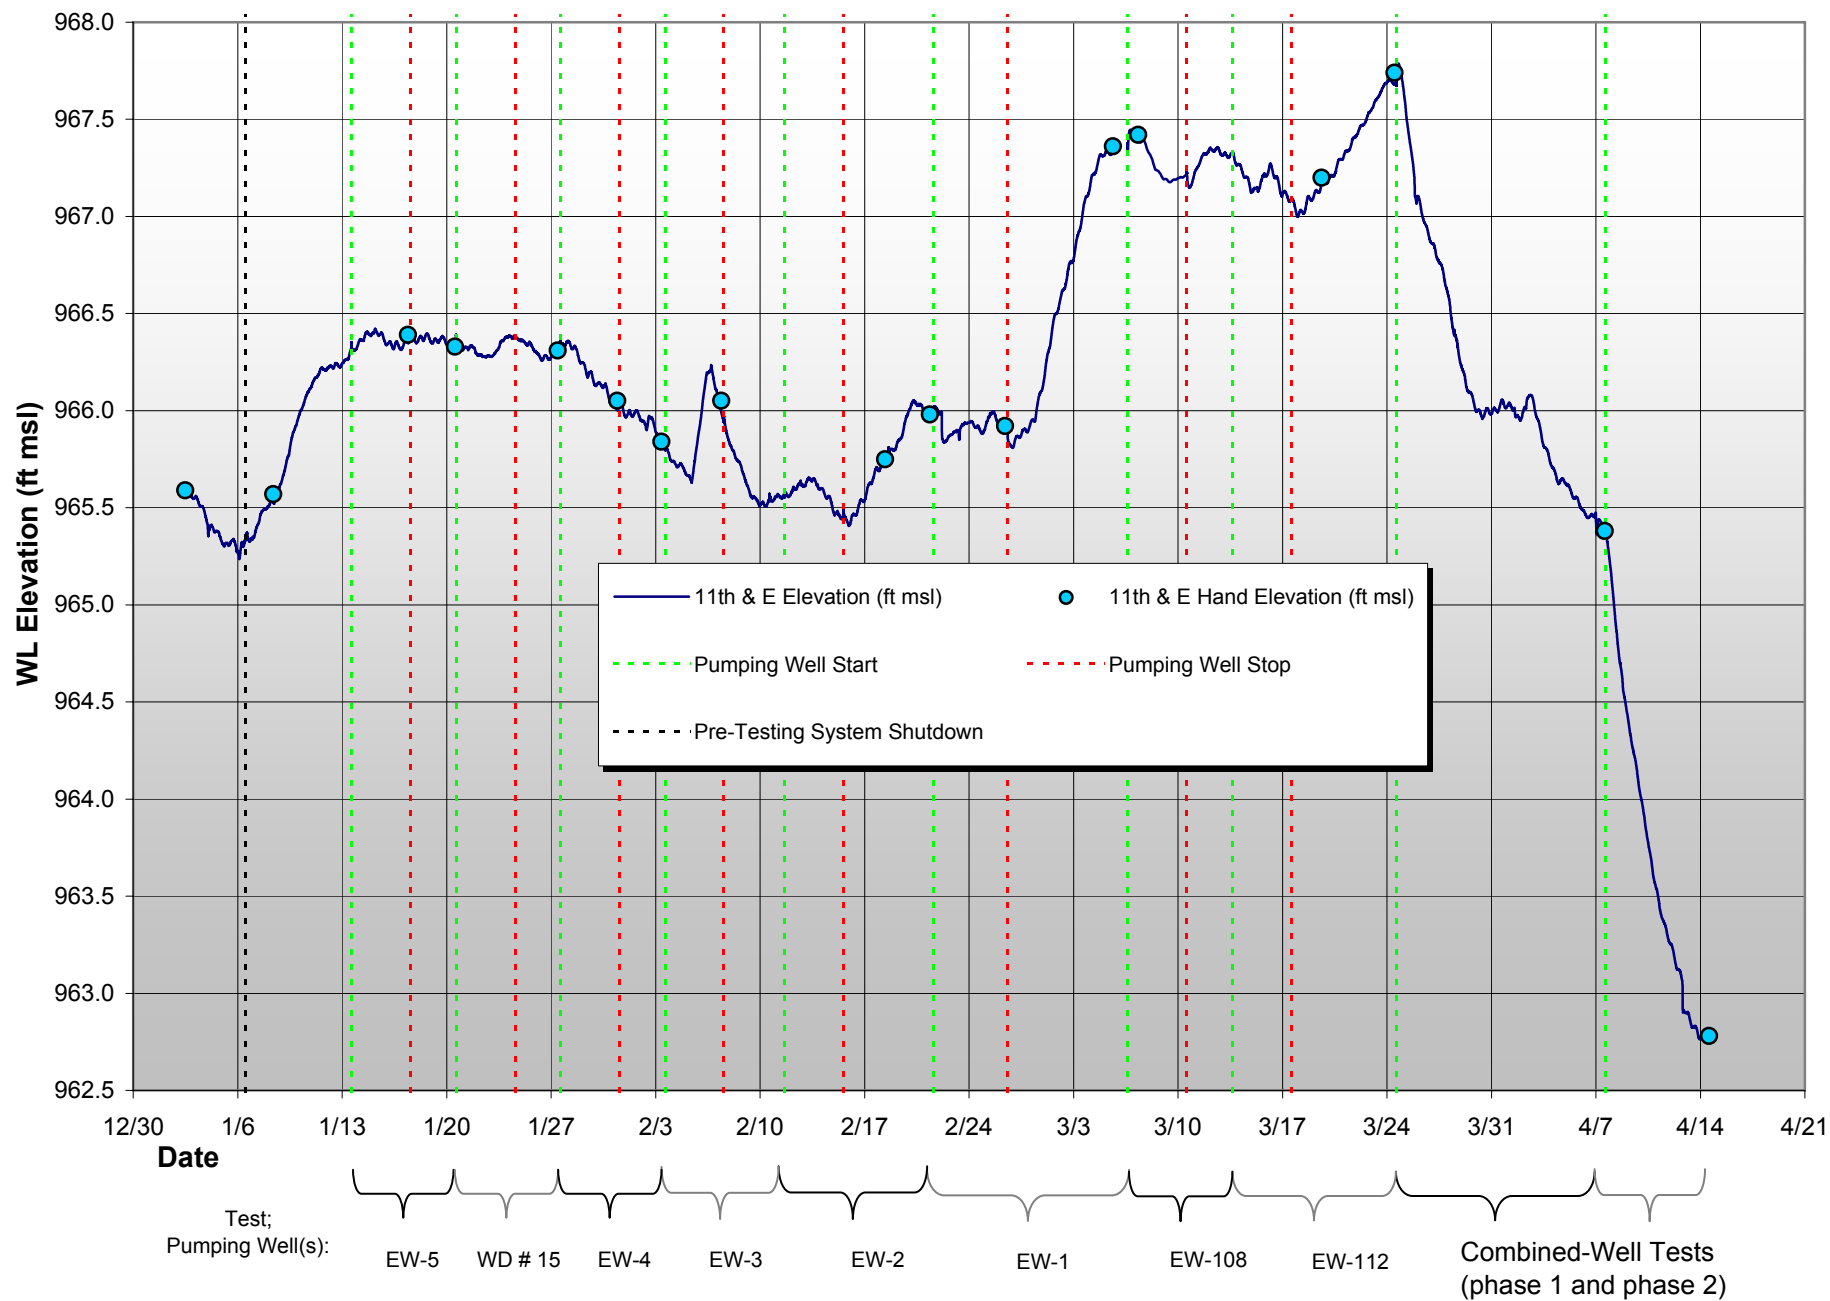
**Figure A-29**  
**Water-Level Elevations in 11th & E Street Well**

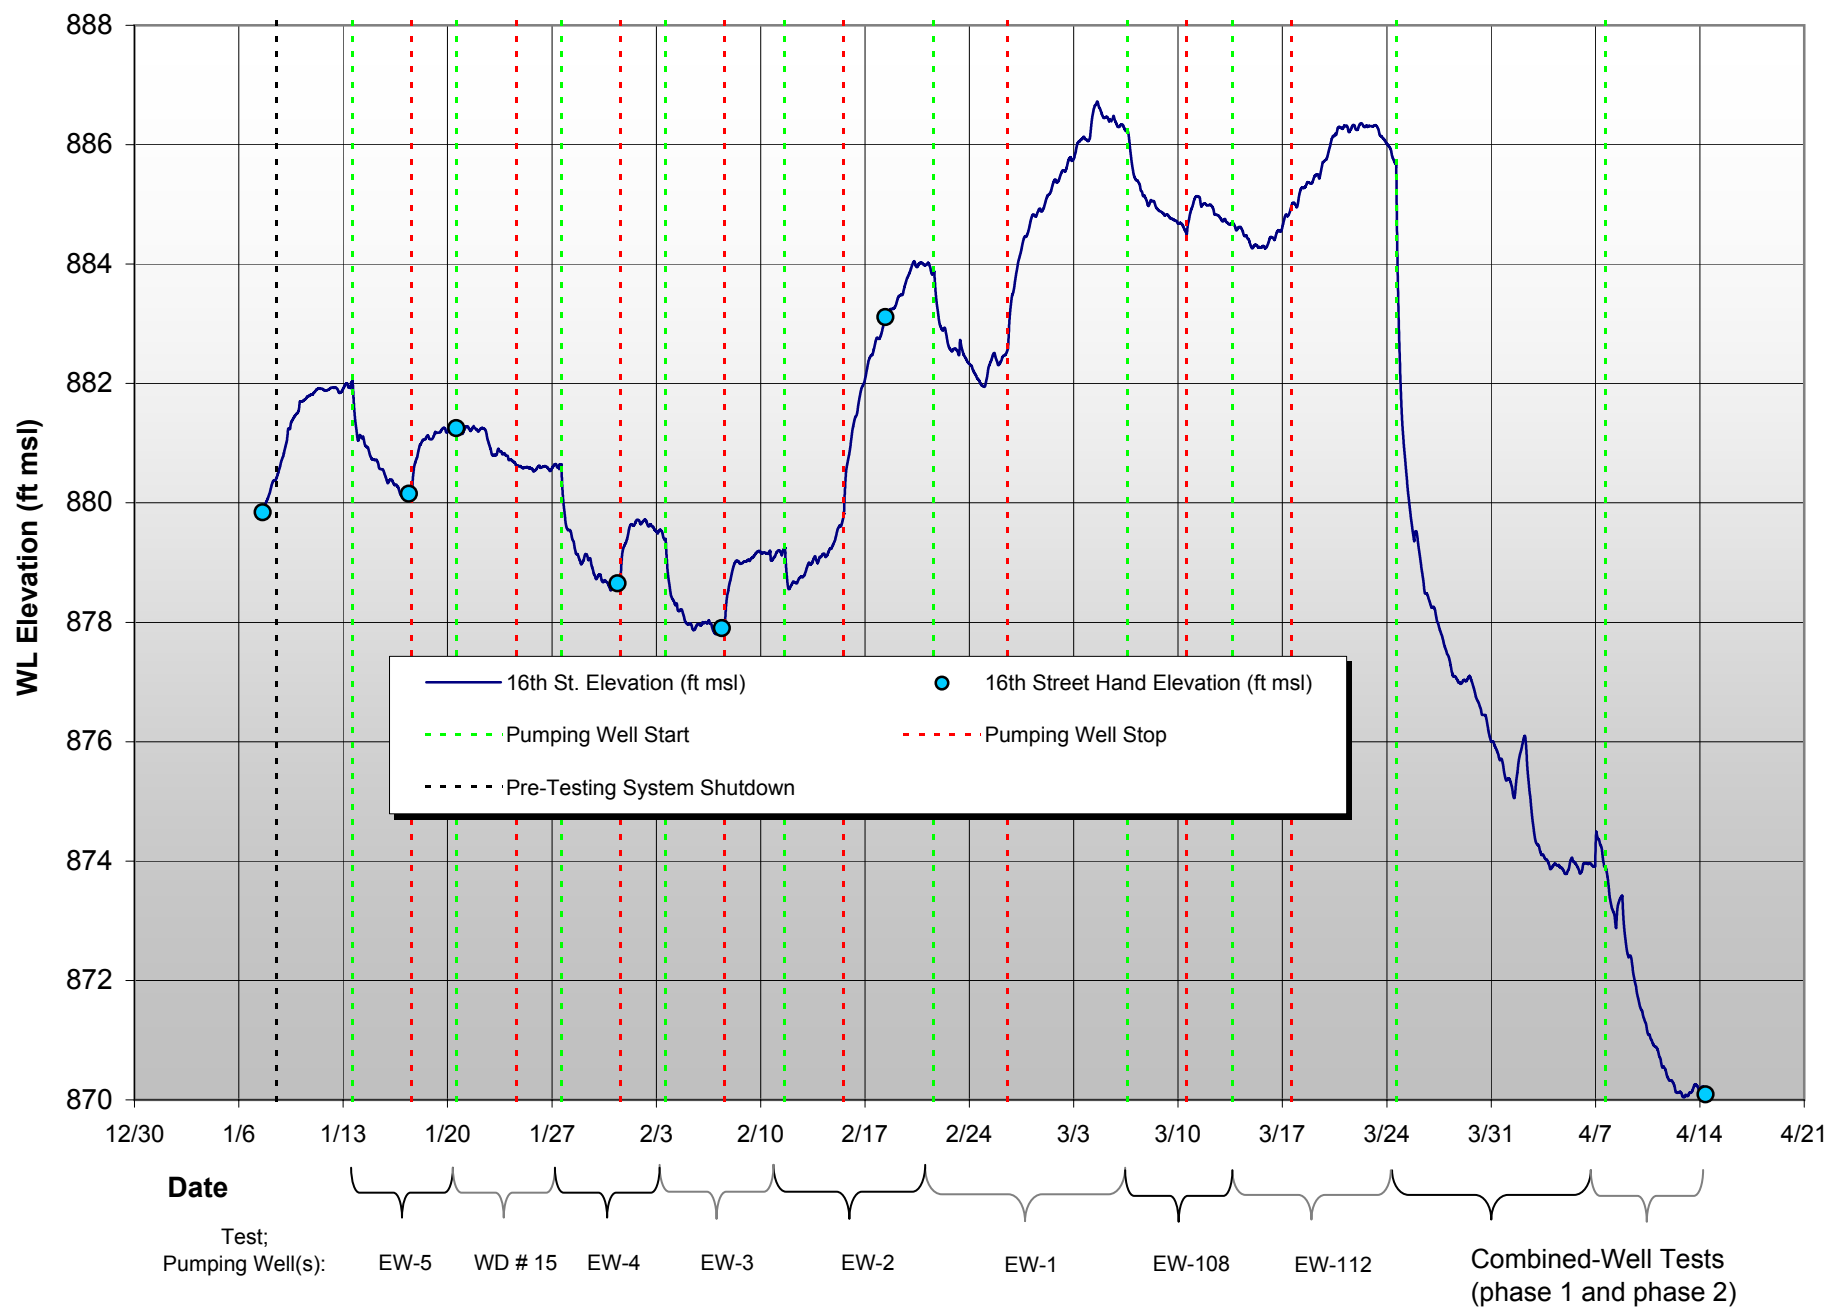
**Figure A-30**  
**Water-Level Elevations in 16th Street Well**

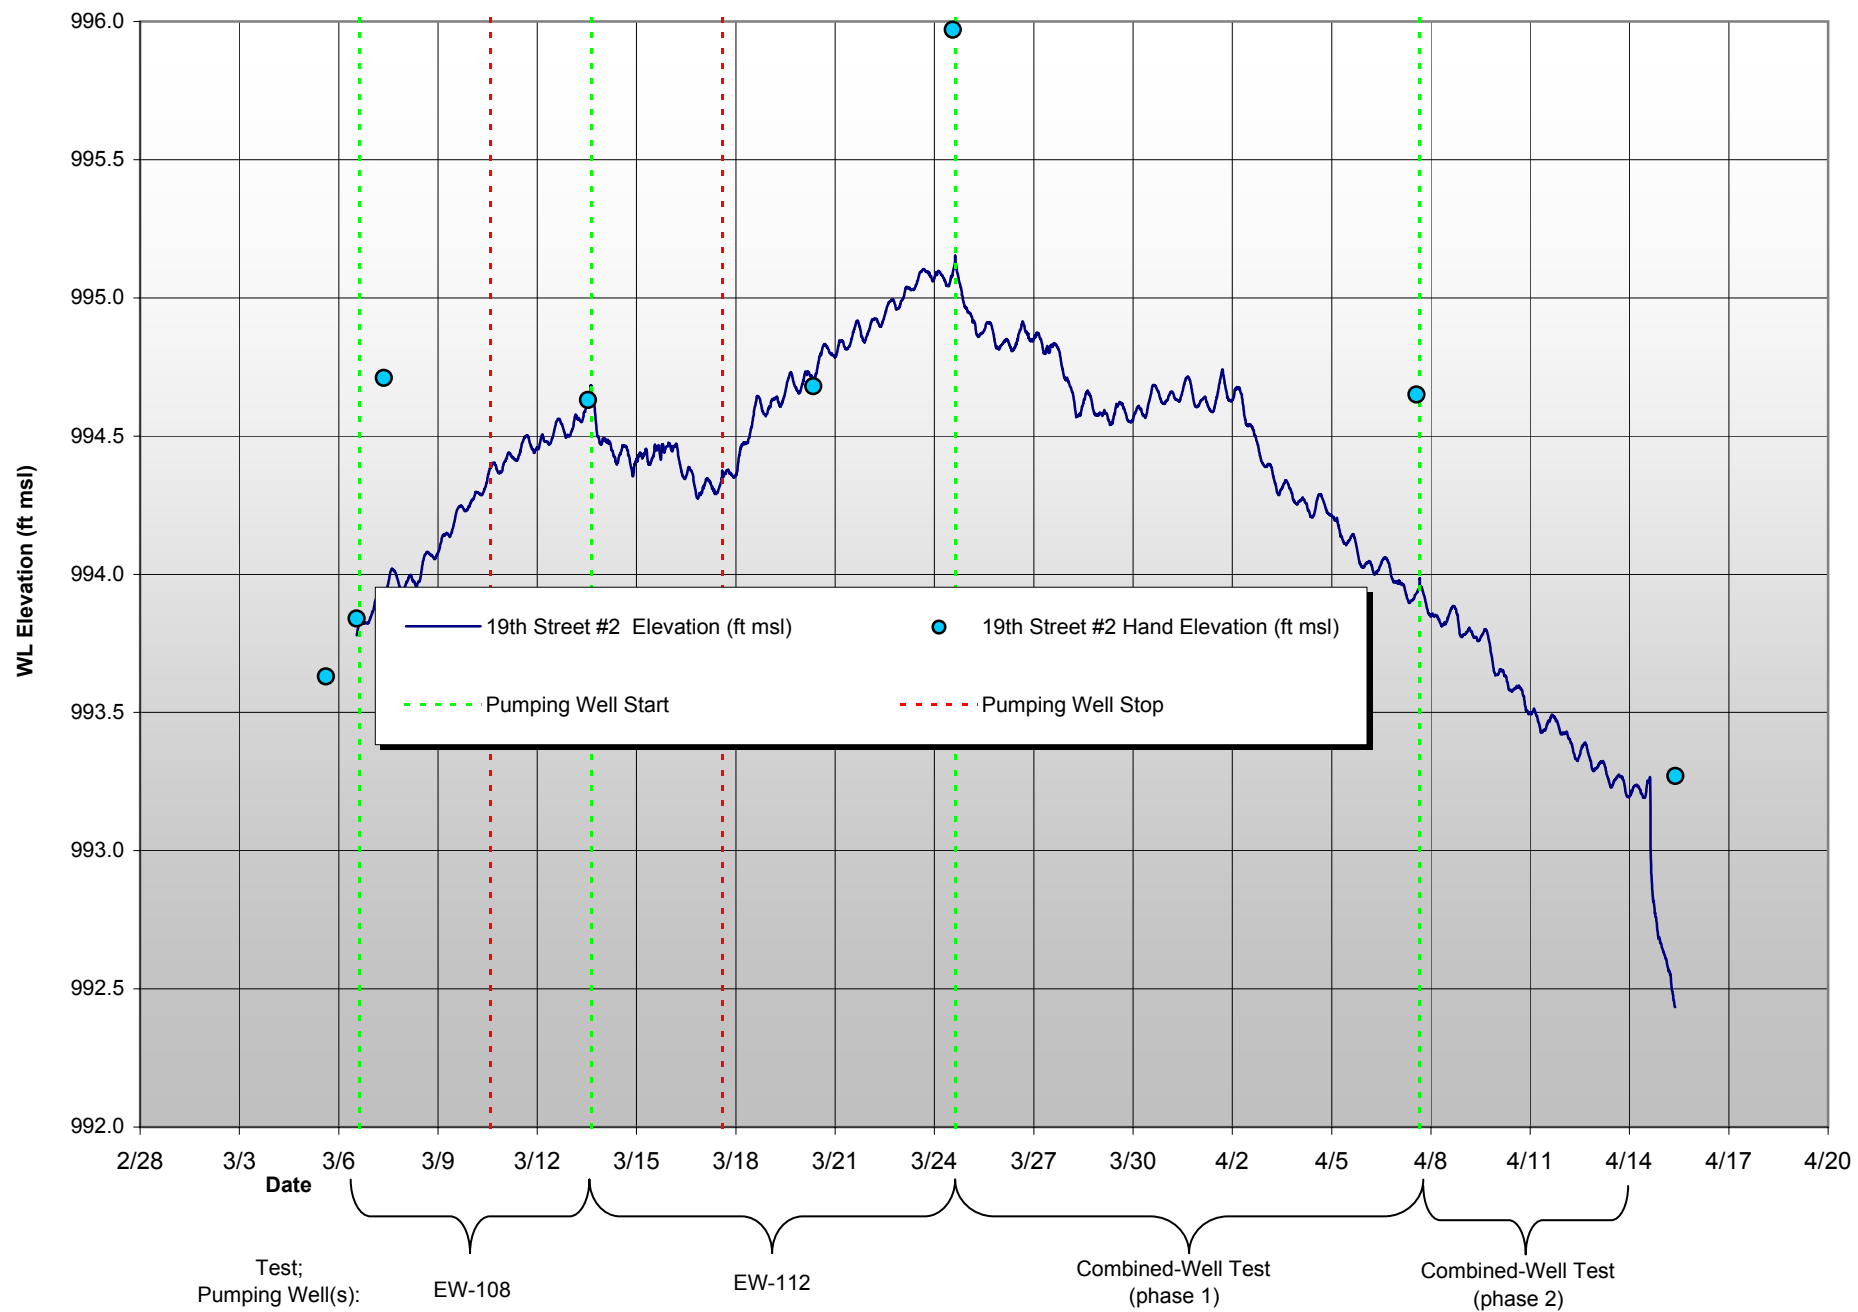
**Figure A-31**  
**Water-Level Elevations in 19th Street #2 Well**

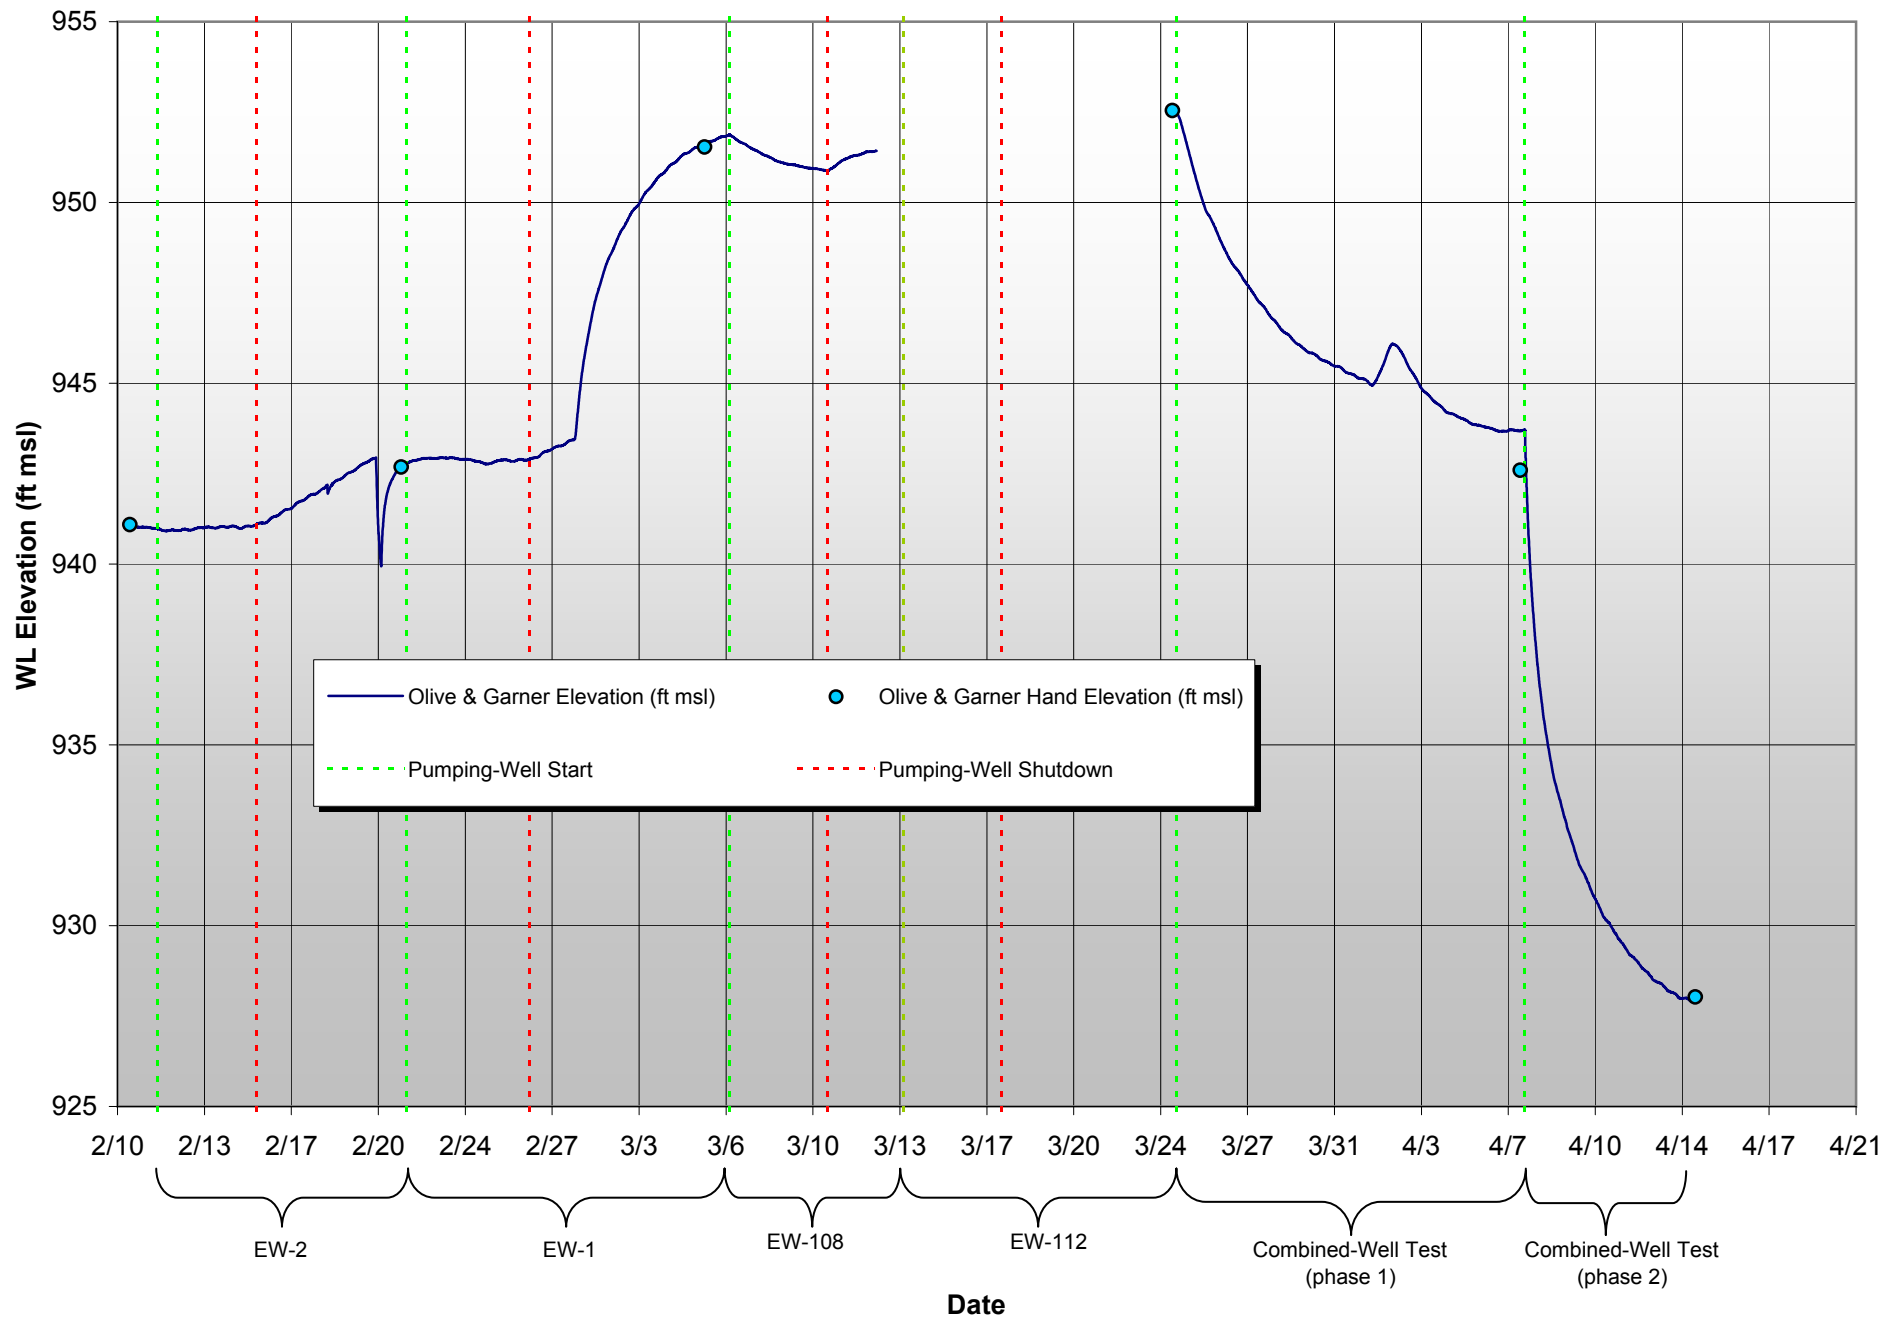
**Figure A-32**  
**Water-Level Elevation in Olive & Garner Well**
